**STRUCTURAL/SEISMIC REPORT
Jackson Elementary School**

Report prepared by DCI Engineers

Medford School District

June 10, 2007

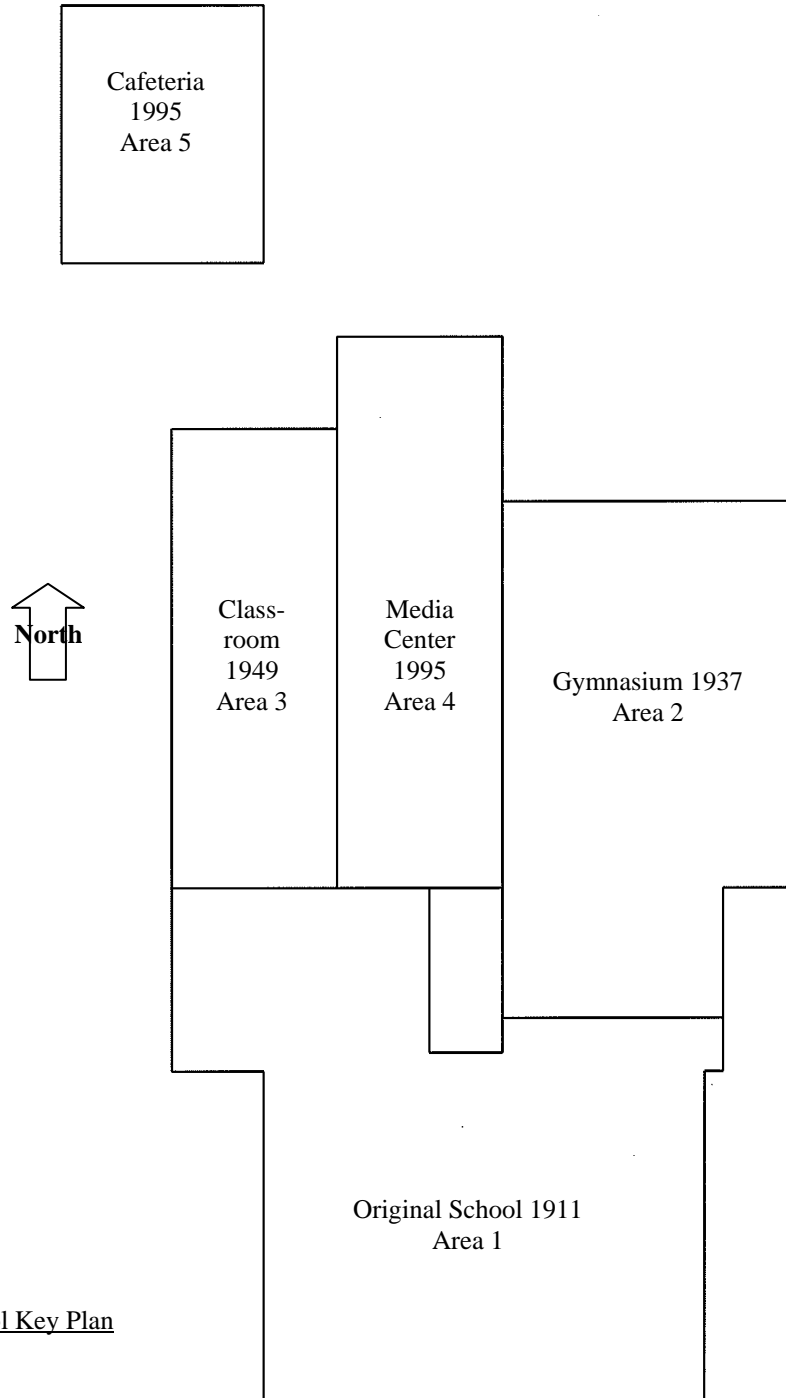
Fig 1- School Key Plan

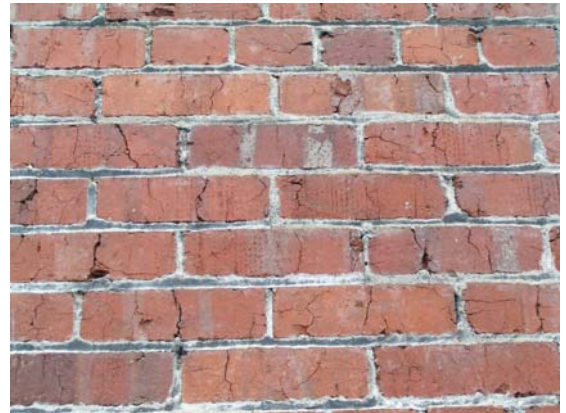
There are several significant concerns associated with the buildings. The first concern is the brick used in the original construction (Area 1). Photo 2 shows the cracking which can be observed over all the exterior and interior faces of the brick walls for this area. Two bricks were removed from the building so that we could review the extent of the cracking on the interior surfaces. Photo 3 shows this brick after it was removed from the exterior wall of the building. Generally the cracks extend through a large portion of the brick. This cracking is likely a result of problems with the firing process. The brick may have been too wet or dry when fired. However, whatever the cause of the cracking these bricks represent a significant concern for this area of the building. They are very brittle and have a low strength. Generally unreinforced brick performs very poorly during an earthquake and would need to be upgraded by backing the walls with a layer of reinforced concrete. Based on the extent of cracking associated with the brick we would recommend that the exterior walls be completely replaced. Since there are other significant changes needed to the buildings related to the mechanical and electrical systems and ADA requirements it may not be cost effective to try and save this building.

Photo 2- Cracking of bricks

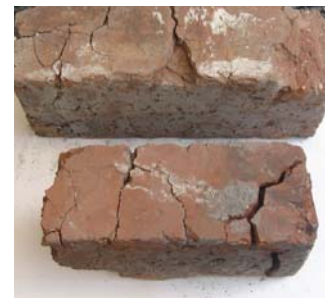
Photo 3- Exterior Cracked Bricks

At the request of Mark Button we have also reviewed the structural risk associated with the continued use of this building for two more years. The concern is the potential for an earthquake which might cause life threatening damage. Since we observed the brick cracking on both the outside face of the wall and the inside we are reasonably confident that this cracking extends throughout the wall. We have not encountered this type of brick failure on other buildings and we do not know of any test data regarding its performance during an earthquake; however it does appear that the cracks have substantially weakened the bricks and it is likely that any significant lateral seismic load could cause the brick to crack.
