**STRUCTURAL/SEISMIC REPORT
Roosevelt Elementary School**

Report prepared by DCI Engineers

Medford School District

May 29, 2007

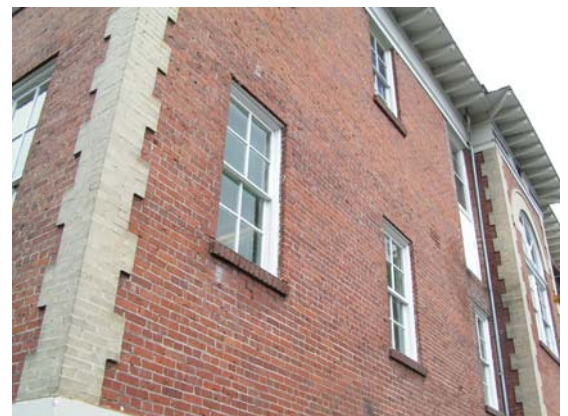
This was the original school building and includes administrative areas and some classrooms. It was constructed in the 1911. The structure is two stories tall with wood framed roofs and floors and perimeter unreinforced brick masonry walls.

Photo 1- Original Building

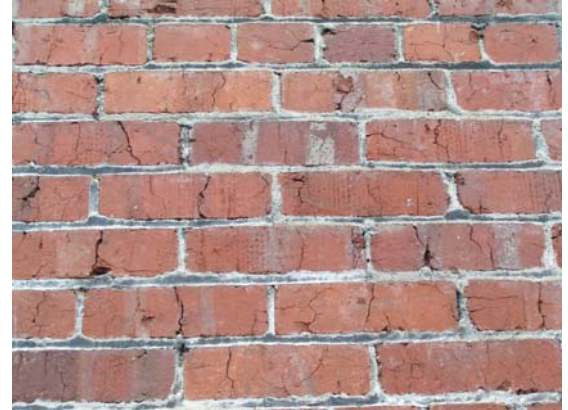
Photo 2- Cracking of bricks

There are several significant concerns associated with the buildings. The first concern is the brick used in the original construction (Area 1). Photo 2 shows the cracking which can be observed over all the exterior and interior faces of the brick walls for this area. Two bricks were removed from the building so that we could review the extent of the cracking on the interior surfaces. Photo 3 shows this brick after it was removed from the exterior wall of the building. Generally the cracks extend through a large portion of the brick. This cracking is likely a result of problems with the firing process. The brick may have been too wet or dry when fired. However, whatever the cause of the cracking these bricks represent a significant concern for this area of the building. They are very brittle and have a low strength. Generally unreinforced brick performs very poorly during an earthquake and would need to be upgraded by backing the walls with a layer of reinforced concrete. Based on the extent of cracking associated with the brick we would recommend that the exterior walls be completely replaced. Since there are other significant changes needed to the buildings related to the mechanical and electrical systems and ADA requirements it may not be cost effective to try and save this building.

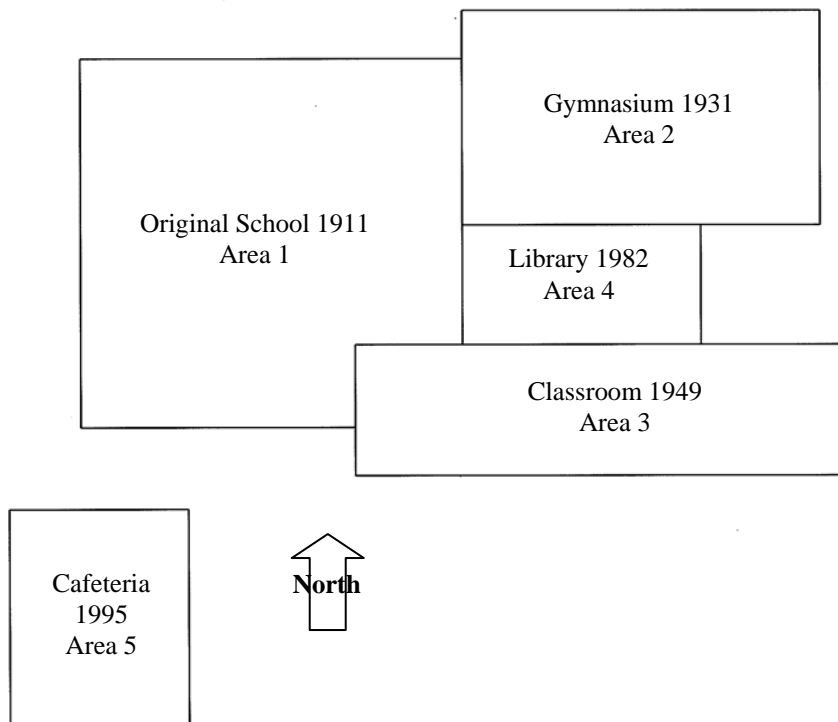
Fig 1- School Key Plan

The school consists of the following five main areas (Fig 1) which represent distinct structures which were built at different times:

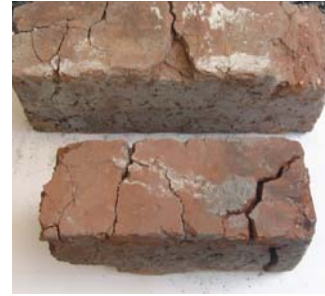
Photo 3- Exterior Cracked Bricks

At the request of Mark Button we have also reviewed the structural risk associated with the continued use of this building for two more years. The concern is the potential for an earthquake which might cause life threatening damage. Since we observed the brick cracking on both the outside face of the wall and the inside we are reasonably confident that this cracking extends throughout the wall. We have not encountered this type of brick failure on other buildings and we do not know of any test data regarding its performance during an earthquake; however it does appear that the cracks have substantially weakened the bricks and it is likely that any significant lateral seismic load could cause the brick to crack. This cracking in combination with other typical URM concerns such as the lack of anchorage between the walls and roof means Roosevelt is likely the most hazardous school building (from a seismic performance standpoint) in the Medford School District.

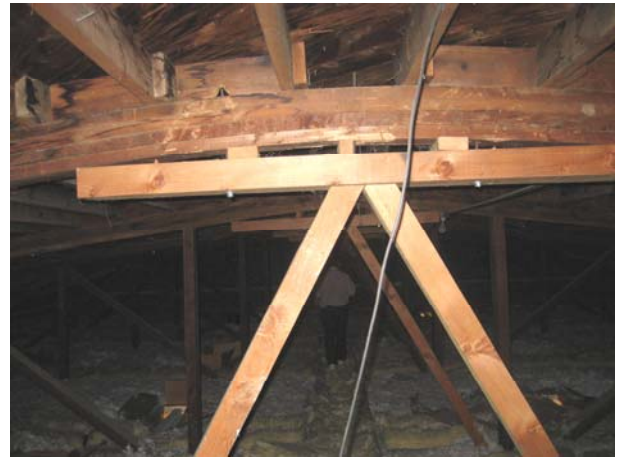
Fig 2- Repaired Roof Truss Area 2

The second concern we found is with the gymnasium. This building is unreinforced masonry and also has wood framed bowstring trusses. We observed repairs to these trusses due to previous failures (Fig 2). These repairs appear to only marginally address the structural concerns. A major school renovation would warrant further study of these trusses and most likely additional repairs.

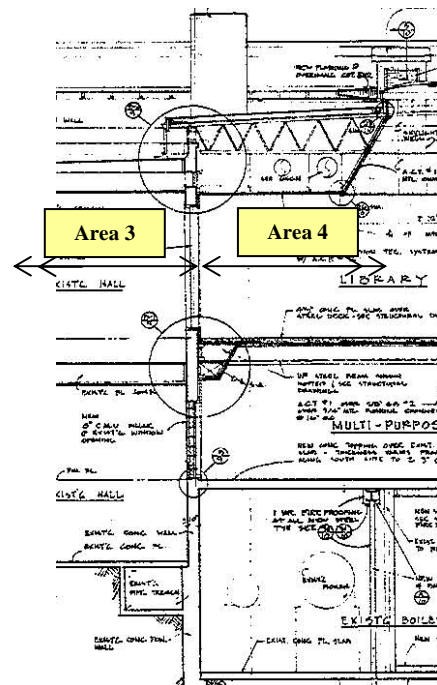
Fig 3- Wall Section

The final concern is related to Area 4. This building has combination of lateral elements including being braced off the 1949 building (Area 3). Any upgrade of this building would need address its interaction with the adjacent 1949 building. Of particular concerns is that the floor and roof of this building does not align with the floor and roof of the 1949 area (Fig 3). This offset would likely overstress the wall during an earthquake. Since this building area is relatively small our recommendation would be to demolish it and save just Area 3. While Area 3 is older it does have substantial concrete shearwalls in each direction and should perform well if the attached media center building were removed.
