Limited Exterior Masonry Assessment Jackson Elementary School

November 29, 2007

Produced for:
Medford Public Schools
Medford, Oregon

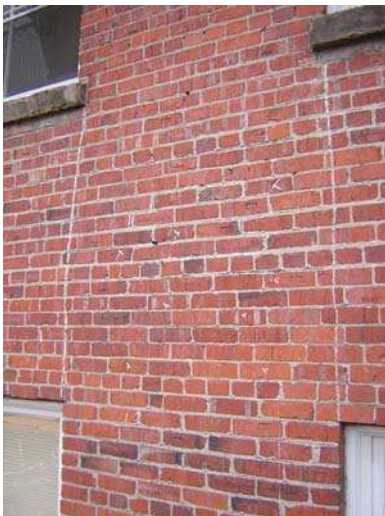
A significant visual difference is evident in comparing the material quality and labor workmanship between the rust colored brick and the blond brick. The blond brick has a very smooth surface void of imperfections and irregularities and was installed with ¼” or less masonry joints. The rust colored brick, however, exhibits numerous surface cracking, spalling of edges due to the cracking, and an irregular surface with many “imperfections.” One such imperfection is a 2” long horizontal indentation likely made from a tool used to remove the masonry units during the firing process. Mortar joints are struck flush with the brick face and are 3/8” to ½” wide. Header courses occur every 8th course vertically and the field bricks were laid in a running

bond. The irregularities, cracking, and workmanship were observed on all three facades of Jackson Elementary School with consistent and similar amounts.

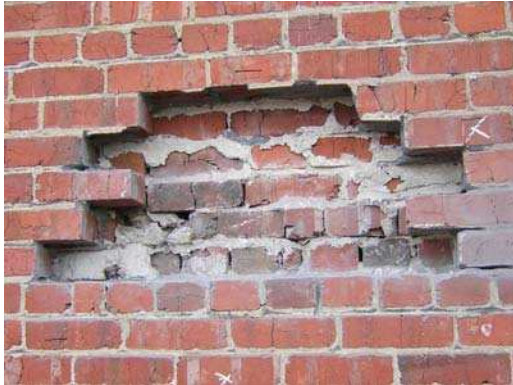
After consultation on site with ABHT Structural Engineers and Rogue Valley Masonry, Peter Meijer Architect, LLC selected two locations at the level of the second floor framing on the east and west elevations as being representative of existing conditions. An area approximately 10ft x 10ft square was marked and each individual brick unit was observed for cracking. Approximately 100 brick units, not counting the header courses, were contained within the boundaries of the area. Of these 100 brick, only seven (7) units were noted to be either without cracks or very minor cracks.

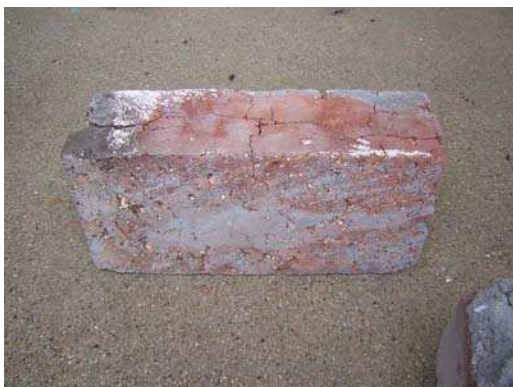
After noting the condition of the face bricks, approximately 15 units were removed from the wall in an area roughly 3 running units wide by five courses high. The lower boundary of the opening was made just above the header course in order to verify the bonding and construction techniques. The initial removal process used a masonry saw to cut the horizontal joints followed by hand tools to scrape out the remaining mortar. After the initial brick units were removed, the removal process was

The masonry courses are set in full bed joints, full back side joints, and head joints all of which meet industry standard construction practices. Although the mortar is “soft,” the existing mortar joints are not exhibiting signs of failure. PMA conducted a limited observation of interior walls but did not observe signs of water intrusion. Mortar within the joints had not failed due to water intrusion or other sources. PMA did not conduct petrographic analysis on the existing mortar, but physical observation combined with knowledge of historic mortars suggests that the existing mortar is lime based. The bed and head mortar of the face veneer has been colored a dark grey. The mortar used for setting the back-up wythes and bonding the face wythe to the back up wythes is an off-white color.

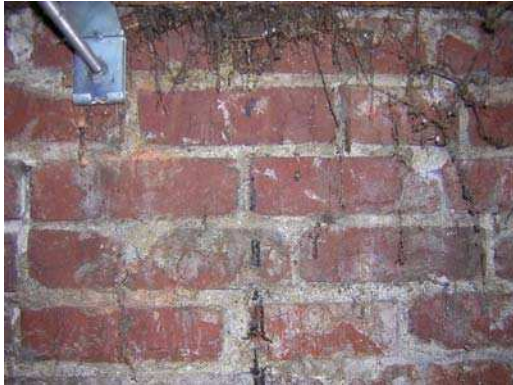
When the mortar was removed, the brick units were dismantled using hand tools. Each unit was removed intact and no units crumbled or broke with hand pressure. It was observed that the cracks on the exterior face did not propagate the full depth of the unit but were present on all six faces. The bedding surfaces of the units contain several inclusions of large sand and rock fragments and has an overall rough texture. The prevalent cracking appears to result from the clay composition and

shrinkage during drying as a result of the manufacturing process. When the cracking is clustered at the edges and corners, a portion of the unit is more likely to spall resulting in deformation of the face. The cracking and material composition was consistent from unit to unit and consistent at both elevations.

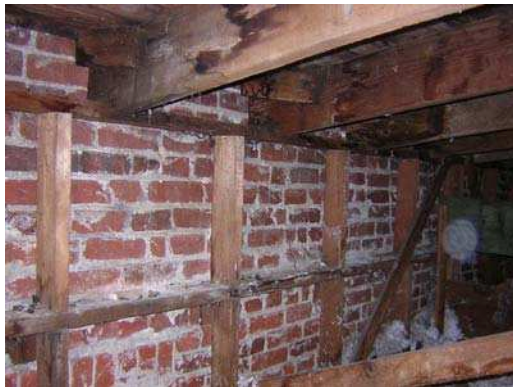
The back-up wythes (middle and interior) were observed from the exterior and attic levels respectively and found to be similar in color, composition, and texture. The number, type, and distribution of cracks in the back-up wythes was similar to the face veneer. At the attic level, previous seismic reinforcement of the roof joists consisted of connecting a steel strap to the inner masonry wythe with epoxy anchored bolts. No additional fracturing or cracking of the masonry wythes was observed at these locations.

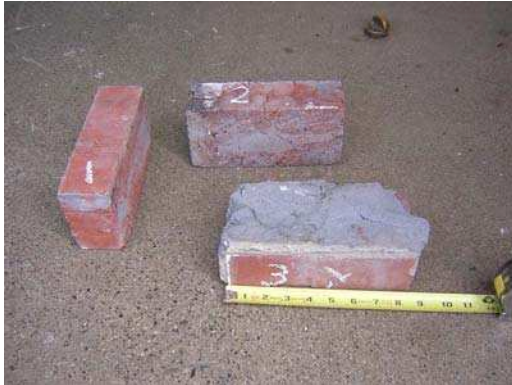
The cracking in the units appear to be the result of manufacturing process and not accelerated aging or water penetration. Based on our review of the brick samples taken in the field, it appears that the cracking present in the bricks may have resulted from rapid cooling after the firing process was completed. Excessively rapid cooling can result in cracking and checking of the clay brick units. Although unsightly, the cracks are not expected to increase in size over time as a result of the firing process. When removed, none of the individual brick units failed.

Due to the amount of surface cracking, some edges and faces of the existing units are spalling and will continue to spall in the future. The water absorption test results are noted above. These results were within acceptable limits for water absorption based on durability classification but slightly out of acceptable range for saturation coefficient. The susceptibility of the brick units to freeze thaw is being evaluated through controlled laboratory tests. The results of the freeze thaw testing will add to the information regarding water absorption characteristics and be incorporated into this report when available.
