# **Limited Exterior Masonry Assessment Roosevelt Elementary School**

Volume 2 of 2

November 29, 2007

Produced for:  
Medford Public Schools  
Medford, Oregon

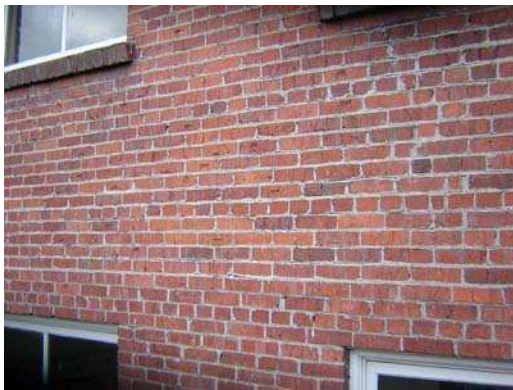
A significant visual difference is evident in comparing the material quality and labor workmanship between the rust colored brick and the blond brick. The blond brick has a very smooth surface void of imperfections and irregularities and was installed with ¼” or less masonry joints. The rust colored brick, however, exhibits numerous surface cracking, spalling of edges due to the cracking, and an irregular surface with many “imperfections.”

One such imperfection is a 2” long horizontal indentation likely made from a tool used to remove the masonry units during the firing process. Mortar joints are struck flush with the brick face and are 3/8” to ½” wide. Header courses occur every 8<sup>th</sup> course vertically and the field bricks were laid in a running bond. The irregularities, cracking, and workmanship were observed on all three facades of Roosevelt Elementary School with consistent and similar amounts.

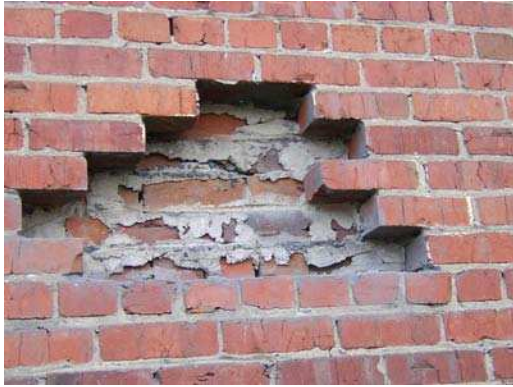
After consultation on site with ABHT Structural Engineers and Rogue Valley Masonry, Peter Meijer Architect, LLC selected two locations at the level of the second floor framing on the east and west elevations as being representative of existing conditions. An area approximately 10ft x 10ft square was marked and each individual brick unit was observed for cracking. Approximately 100 brick units, not counting the header courses, were contained within the boundaries of the

area. Of these 100 brick, only seven (7) units were noted to be either without cracks or very minor cracks.

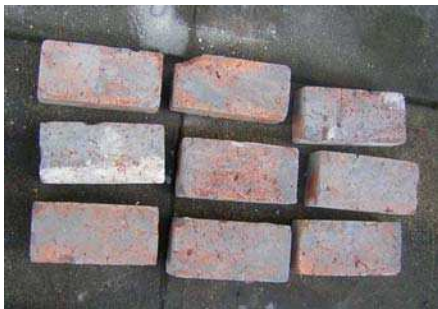
After noting the condition of the face bricks, approximately 15 units were removed from the wall in an area roughly 3 running units wide by five courses high. The lower boundary of the opening was made just above the header course in order to verify the bonding and construction techniques. The initial removal process used a masonry saw to cut the horizontal joints followed by hand tools to scrape out the remaining mortar. After the initial brick units were removed, the removal process was slightly modified to eliminate the use of power tools and utilize only hand tools to remove the mortar.

The masonry courses are set in full bed joints, full back side joints, and head joints all of which meet industry standard construction practices. Although the mortar is “soft,” the existing mortar joints are not exhibiting signs of failure. PMA conducted a limited observation of interior walls but did not observe signs of water intrusion. Mortar within the joints had not failed due to water intrusion or

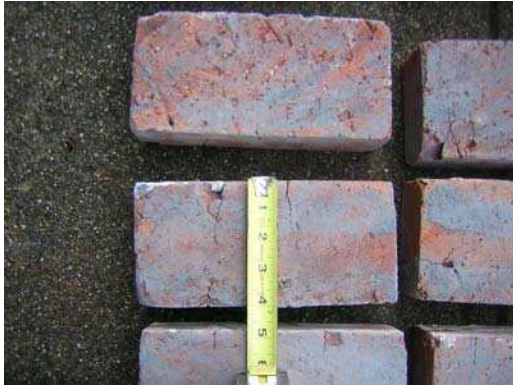
The back-up wythes (middle and interior) were observed from the exterior and attic levels respectively and found to be similar in color, composition, and texture. The number, type, and distribution of cracks in the back-up wythes was similar to the face veneer. At the attic level, previous seismic reinforcement of the roof joists consisted of connecting a steel strap to the inner masonry wythe with epoxy anchored bolts. No additional fracturing or cracking of the masonry wythes was observed at these locations.

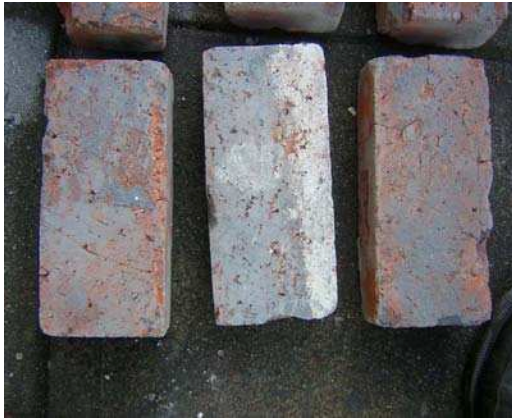
Although the construction methodologies used to build the masonry bearing wall at Roosevelt Elementary School are reflective of standards of the period, it is atypical for an exterior masonry veneer to be comprised of low aesthetic quality bricks. Most public buildings incorporated masonry with high quality clays and control of the manufacturing process that limited drying cracks resulting in higher aesthetic appearances. It is not unusual for back-up masonry to be composed of lower quality units.

The cracking in the units appear to be the result of manufacturing process and not accelerated aging or water penetration. Based on our review of the brick samples taken in the field, it appears that the cracking present in the bricks may have resulted from rapid cooling after the firing process was completed. Excessively rapid cooling can result in cracking and checking of the clay brick units. Although unsightly, the cracks are not expected to increase in size over time. When removed, none of the individual brick units failed.

Due to the amount of surface cracking, some edges and faces of the existing units are spalling and will continue to spall in the future. The water absorption test results are noted above. These results were within acceptable limits for water absorption based on durability classification but slightly out of acceptable range for saturation coefficient. The susceptibility of the brick units to freeze thaw is being evaluated through controlled laboratory tests. The results of the freeze thaw testing will add to the information regarding water absorption characteristics and be incorporated into this report when available.
