Limited Exterior Masonry Assessment Jackson Elementary School

November 29, 2007

Produced for:
Medford Public Schools
Medford, Oregon

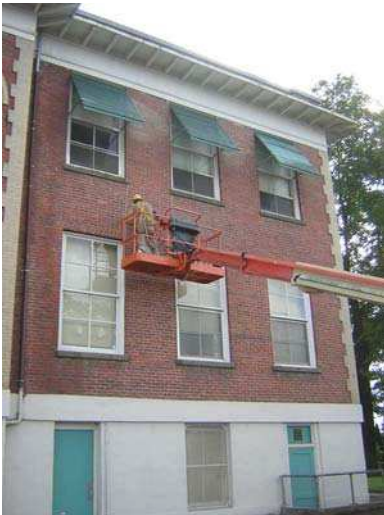
The original circa 1911 wing of Jackson Elementary School consists of a concrete base and a two-story masonry façade with a masonry parapet. A decorative wood cornice consists of projecting wood “false” rafter tails and a wood architrave. The concrete base is a ½ story below grade and the first floor is a ½ story above grade. The major structural systems are a concrete foundation (The basement walls are cast-in-place concrete and extend approximately 8’-0” above the exterior finished grade. The basement floor is concrete slab-on-grade.), an un-reinforced masonry wall composed of three wythes of masonry. (The walls were observed to be (3) wythes thick at the second floor. (We were unable to determine the number of brick wythes from the second floor to roof level) The masonry wall has a face veneer of rust colored brick with blond brick accents, quoining, and blond brick decorative 2-story engaged columns. Both the roof trusses and the floor framing members are wood. At the attic level, the roof joists have been anchored to the exterior masonry wall with metal straps nailed to the roof joists and epoxy anchored into the existing masonry wall. Interior finishes include wood floors, plaster walls and ceilings, and wood trim work including a wood wainscot.
